23 August 2016

Scania's new truck range: Safest with rollover side curtain airbags and better brakes

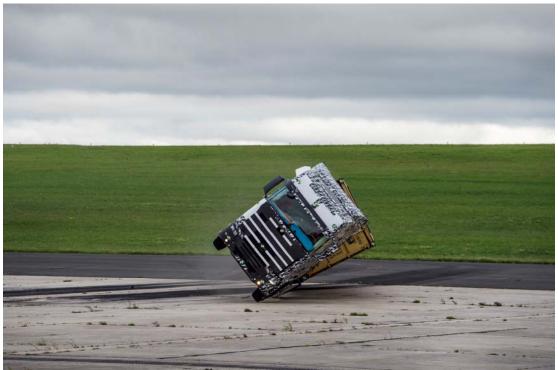
Both the structure and the complete cabs in Scania's new truck range undergo a wide variety of brutal tests during the development process. Scania's cabs survive tests in which the same cab is subjected to impacts from several directions, corresponding to what happens in a real-life accident in which the truck rolls over, for instance.

The new cabs have been designed and tested to cope with Sweden's tough impact testing (despite the fact that it is no longer a legal requirement), in which the same cab is tested in three different scenarios to simulate a rollover accident. Furthermore, the steering column beneath the steering wheel has been constructed to absorb impact energy and reduce the impact force to which the driver could be subjected.
